Geotechnical Evaluation  
Devil's Punchbowl Nature Center  
Replacement Project  
28000 Devil's Punchbowl Road  
Pearblossom, California

December 9, 2022 | Project No. 212036002

# Geotechnical Evaluation Devil's Punchbowl Nature Center Replacement Project 28000 Devil's Punchbowl Road Pearblossom, California

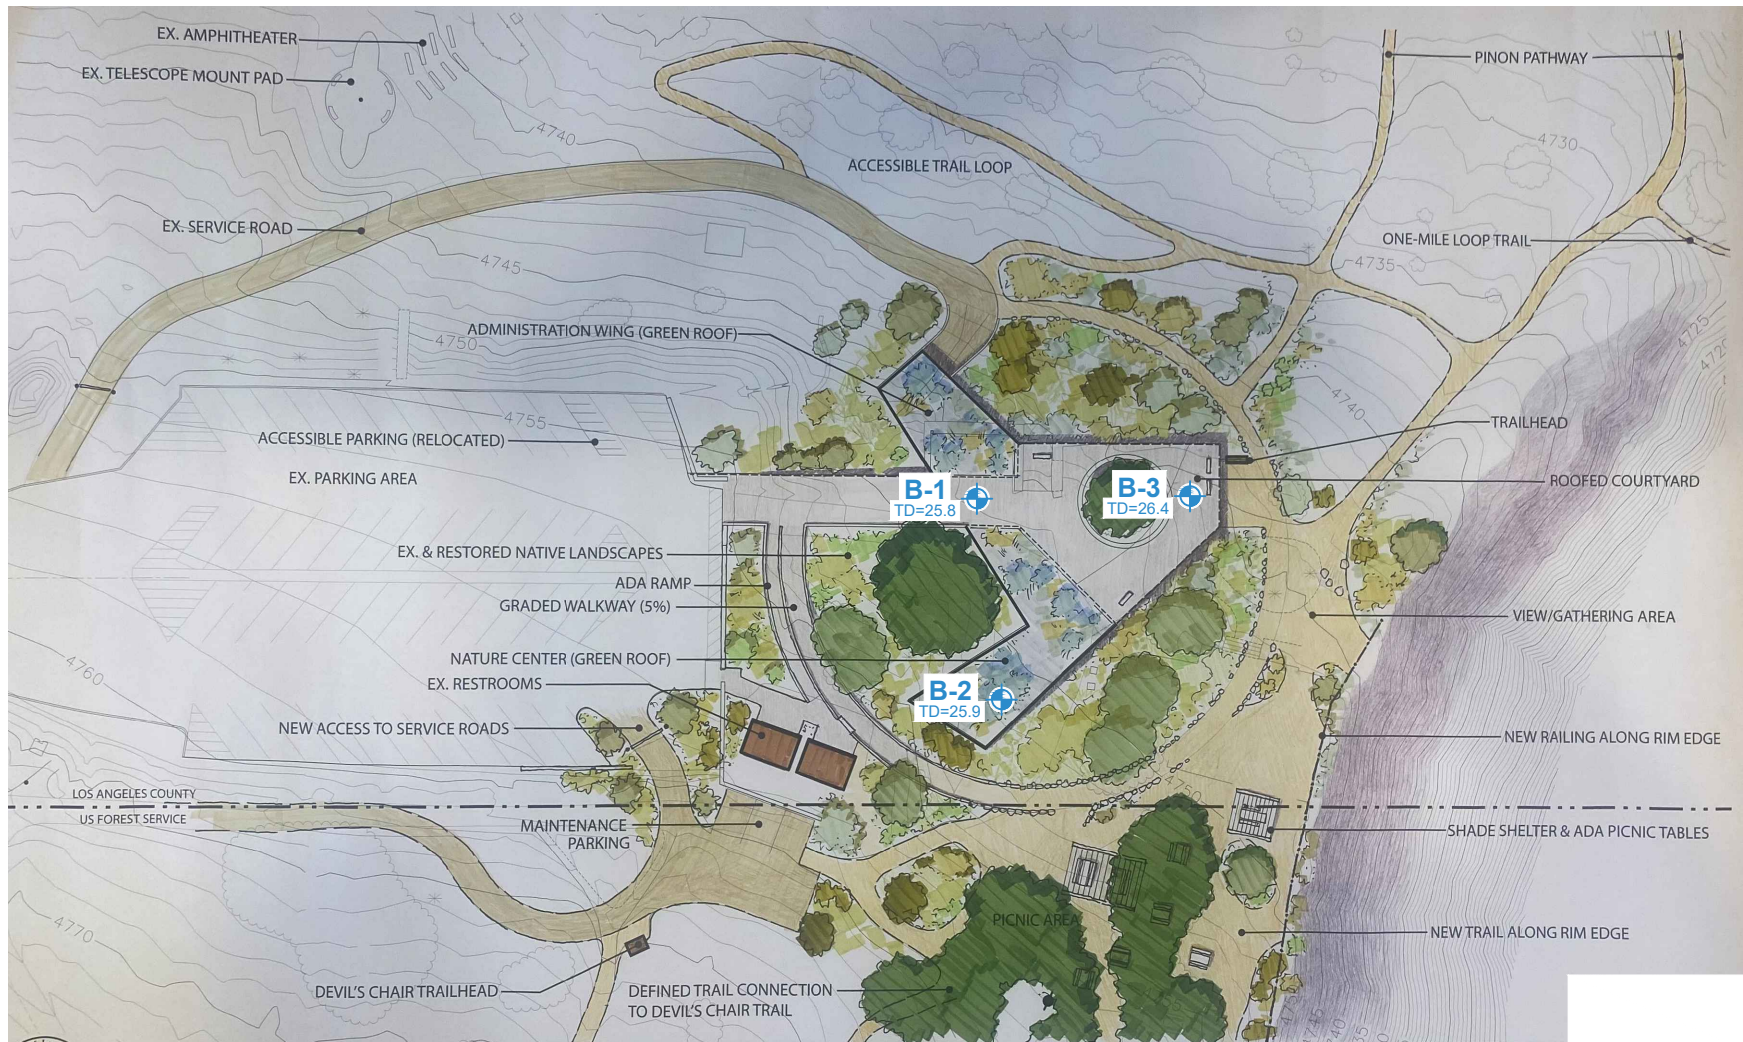
**FIGURE 2**

**B-3** BORING;  
 TD=26.4 TD=TOTAL DEPTH IN FEET

We understand that the project will include replacement of the nature center and improvements to the surrounding areas. The new nature center will consist of a 3,000 square feet reinforced masonry structure that will include the nature center, administrative offices, and a gift shop. The building will have a green roof that will also act as a lookout platform for visitors. Additional site improvements will include picnic areas, shade structures, ADA access to buildings and trails, and improvements to the trailheads (Figure 2).

Our subsurface exploration was performed on October 19, 2022 and consisted of drilling, logging, and sampling of three small-diameter borings using a truck-mounted drill rig with 8-inch-diameter hollow-stem augers to depths of approximately 26 feet. The borings were logged by a representative from our firm and bulk and relatively undisturbed soil and formational samples were obtained at selected depths for laboratory testing. The approximate locations of the borings are presented on Figure 2. The boring logs are presented in Appendix A.

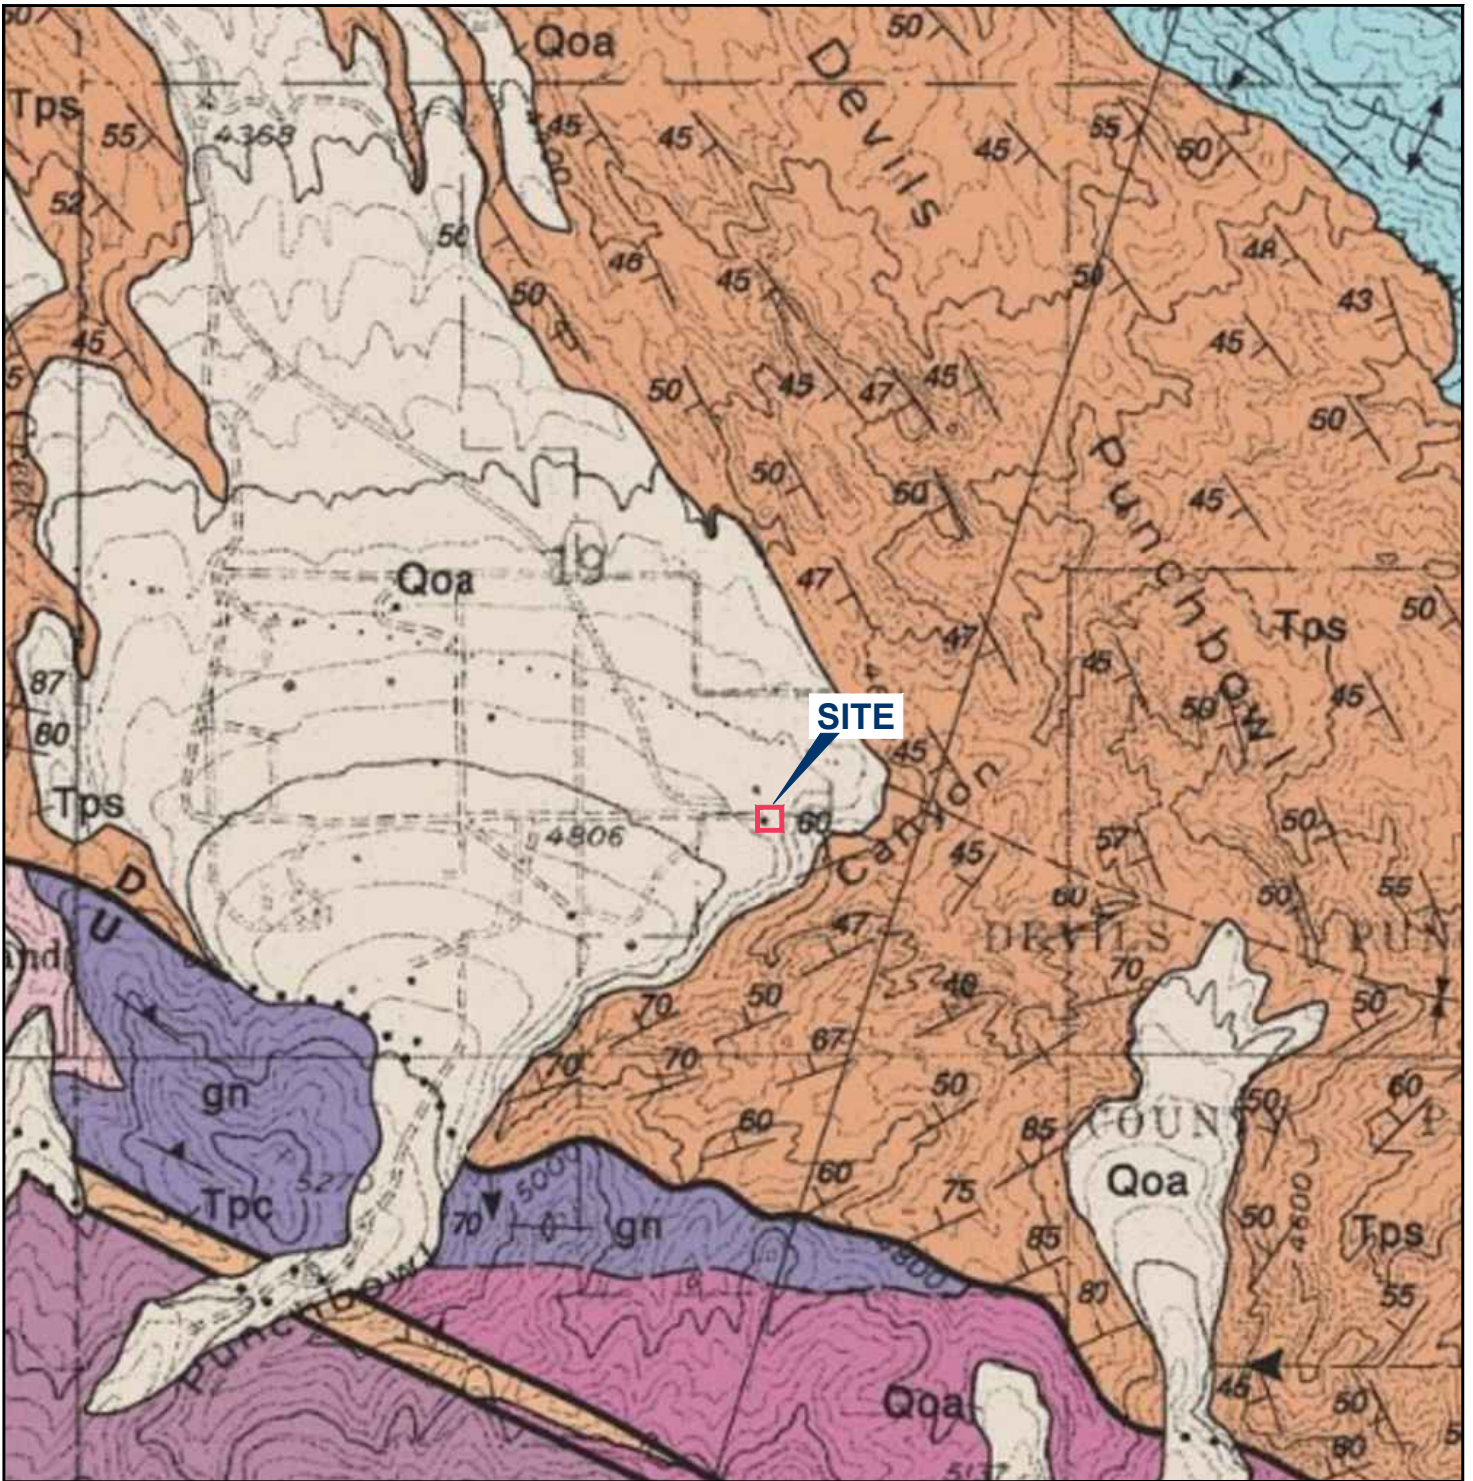
**REGIONAL GEOLOGY**

Qoa	OLDER ALLUVIUM	~	GEOLOGIC CONTACT
Tps	PUNCHBOWL FORMATION	- ··· -	FAULT

Materials encountered during our subsurface exploration consisted of alluvium underlain by formational materials of the Miocene-age Punchbowl Formation to the total depth explored of approximately 26 feet. Alluvium was encountered at the ground surface and extended to depths ranging from approximately 9 to 13 feet below the ground surface. The alluvium generally consisted of dry to moist, medium dense to very dense, silty sand with gravel and poorly graded gravel with silt and sand. Cobbles and boulders were encountered in the alluvium. The Punchbowl Formation was encountered beneath the alluvium and generally consisted of moist, moderately cemented, sandstone with rounded to subrounded gravel. More detailed descriptions of the subsurface materials are presented on the boring logs in Appendix A

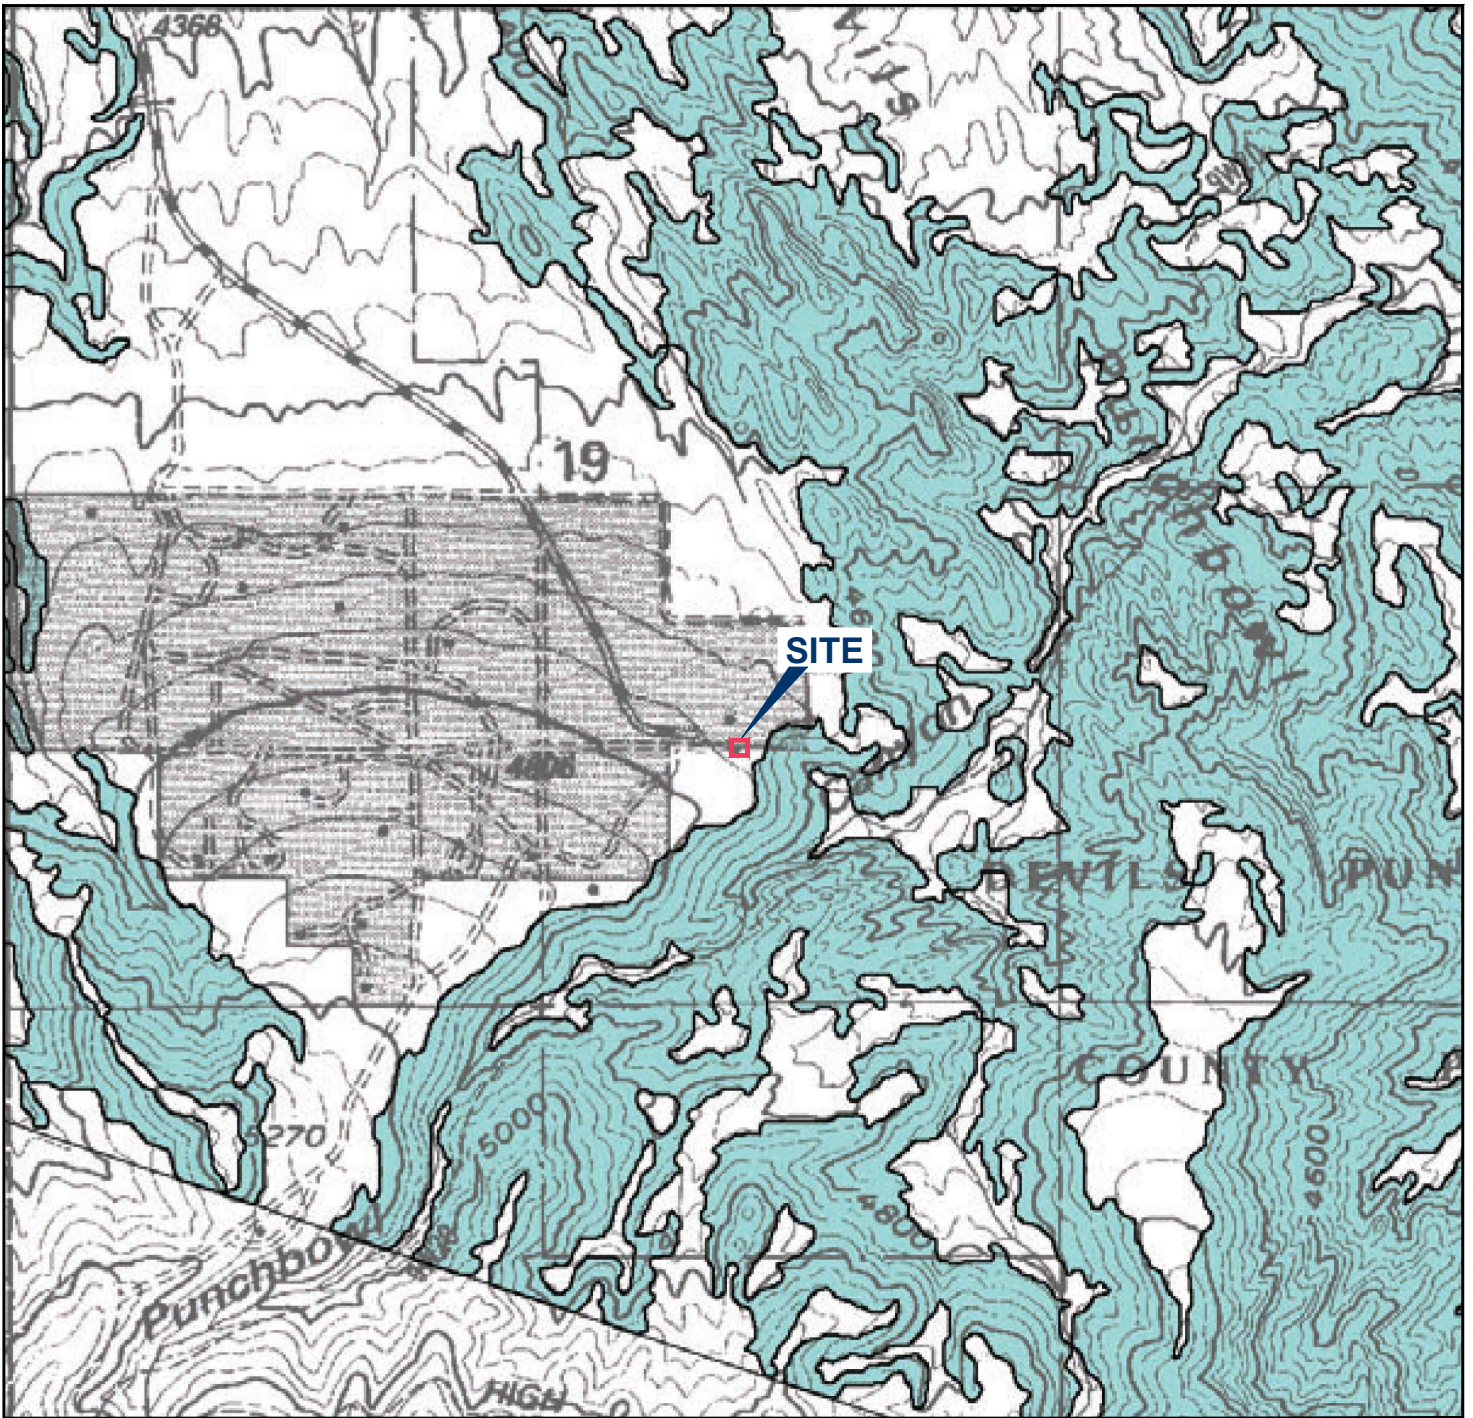
**SEISMIC HAZARD ZONES**

**EARTHQUAKE-INDUCED LANDSLIDES**

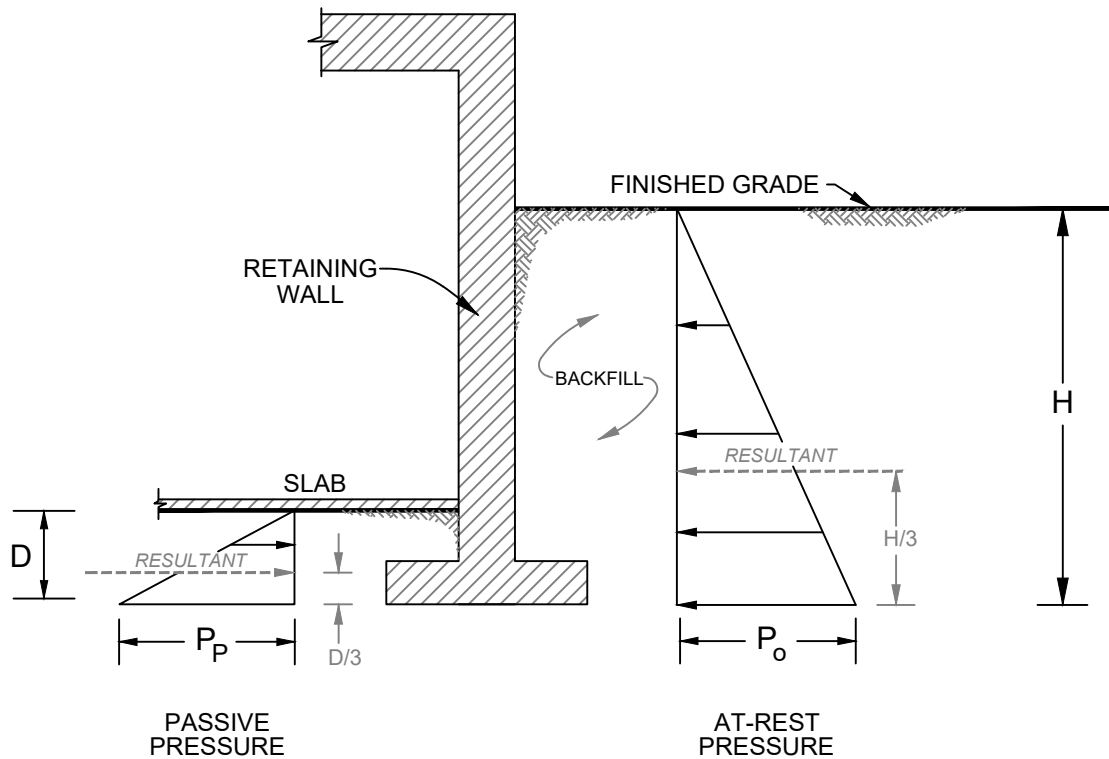
**LATERAL EARTH PRESSURES FOR RESTRAINED RETAINING WALLS**

1. ASSUMES NO HYDROSTATIC PRESSURE BUILD-UP BEHIND THE RETAINING WALL
2. STRUCTURAL, GRANULAR BACKFILL MATERIALS AS SPECIFIED IN GREENBOOK SHOULD BE USED FOR RETAINING WALL BACKFILL
3. DRAINS AS RECOMMENDED IN THE RETAINING WALL DRAINAGE DETAIL SHOULD BE INSTALLED BEHIND THE RETAINING WALL
4. DYNAMIC LATERAL EARTH PRESSURE IS IGNORED AND DEEMED INAPPLICABLE DUE TO THE AT-REST CONDITION OF THE RETAINING WALL
5. SURCHARGE PRESSURES CAUSED BY VEHICLES OR NEARBY STRUCTURES ARE NOT INCLUDED
6. H AND D ARE IN FEET

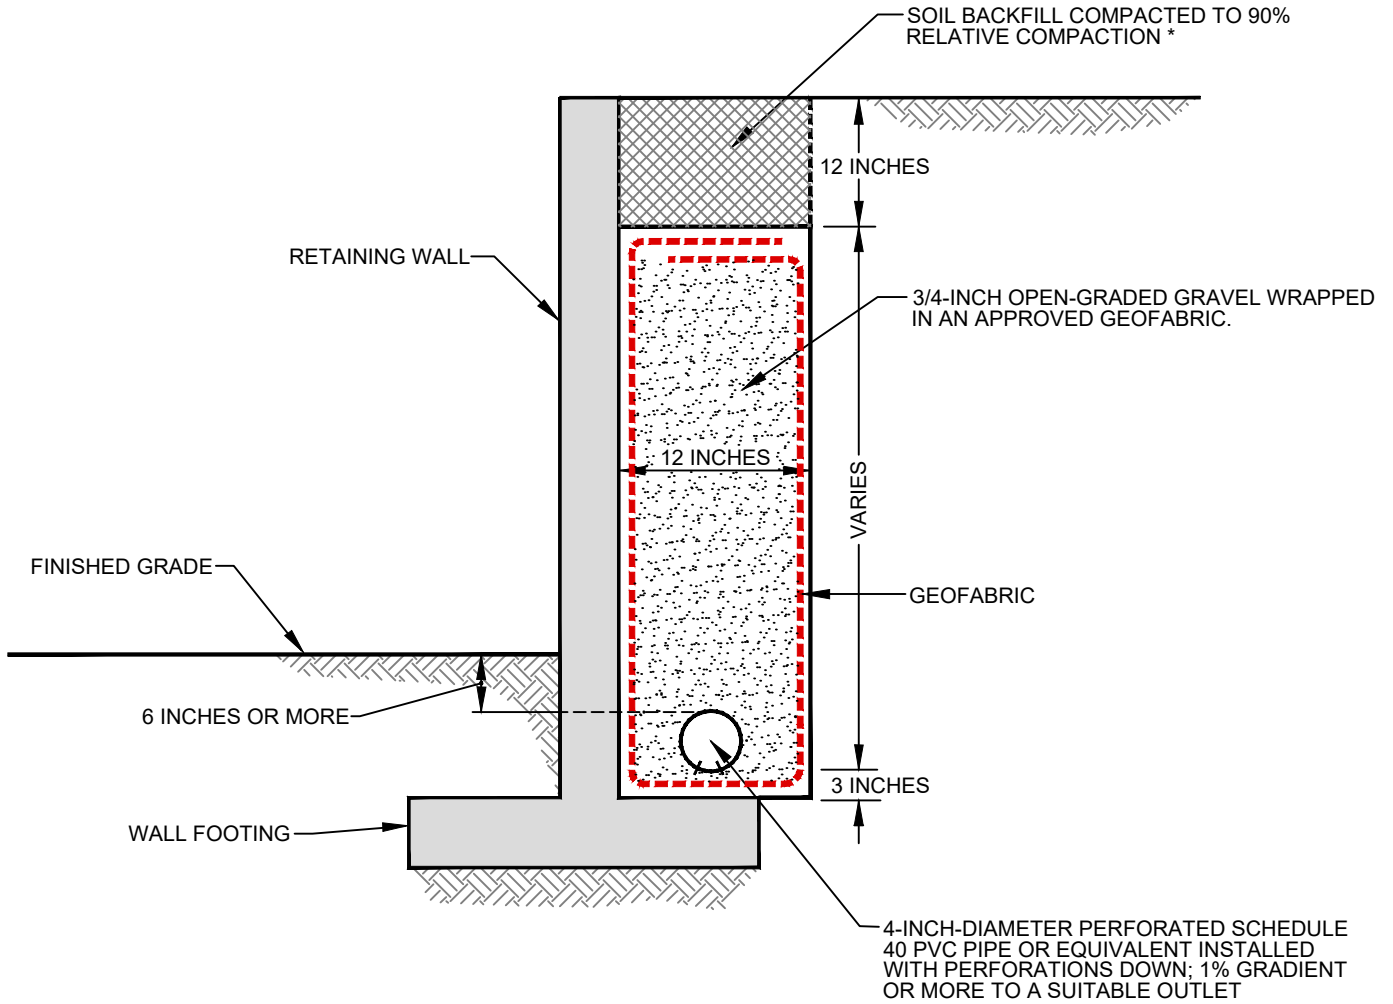
\*BASED ON ASTM D1557

NOT TO SCALE

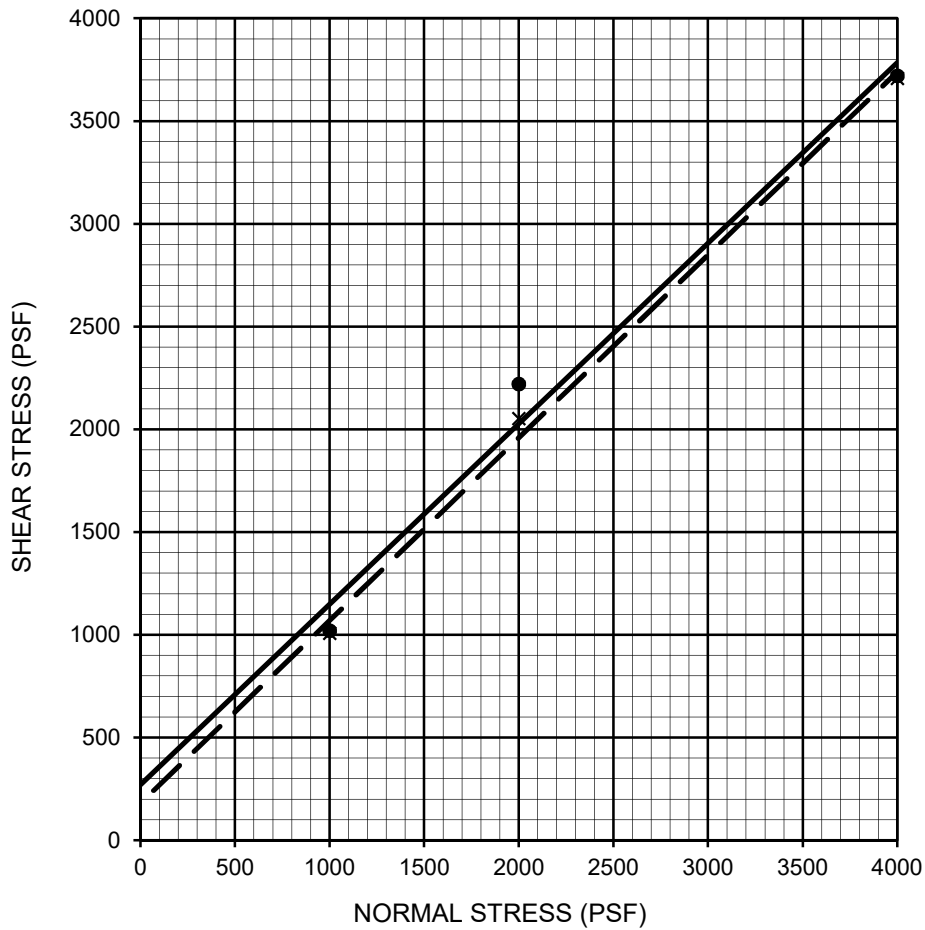
Description	Symbol	Sample Location	Depth (ft)	Shear Strength	Cohesion (psf)	Friction Angle (degrees)	Soil Type
SILTY SAND WITH GRAVEL	—●—	B-1	5.0-6.5	Peak	270	41	SM
SILTY SAND WITH GRAVEL	- - X - -	B-1	5.0-6.5	Ultimate	180	42	SM

PERFORMED IN GENERAL ACCORDANCE WITH ASTM D 3080

Laboratory testing was performed to evaluate in-situ moisture content and dry density, percentage of soil particles finer than the No. 200 sieve, direct shear strength, and corrosivity. The results of our in-situ moisture content and dry density tests are presented on the boring logs in Appendix A. The results of the remaining laboratory tests are presented in Appendix B.
